APPENDIX J – Streambank Alteration

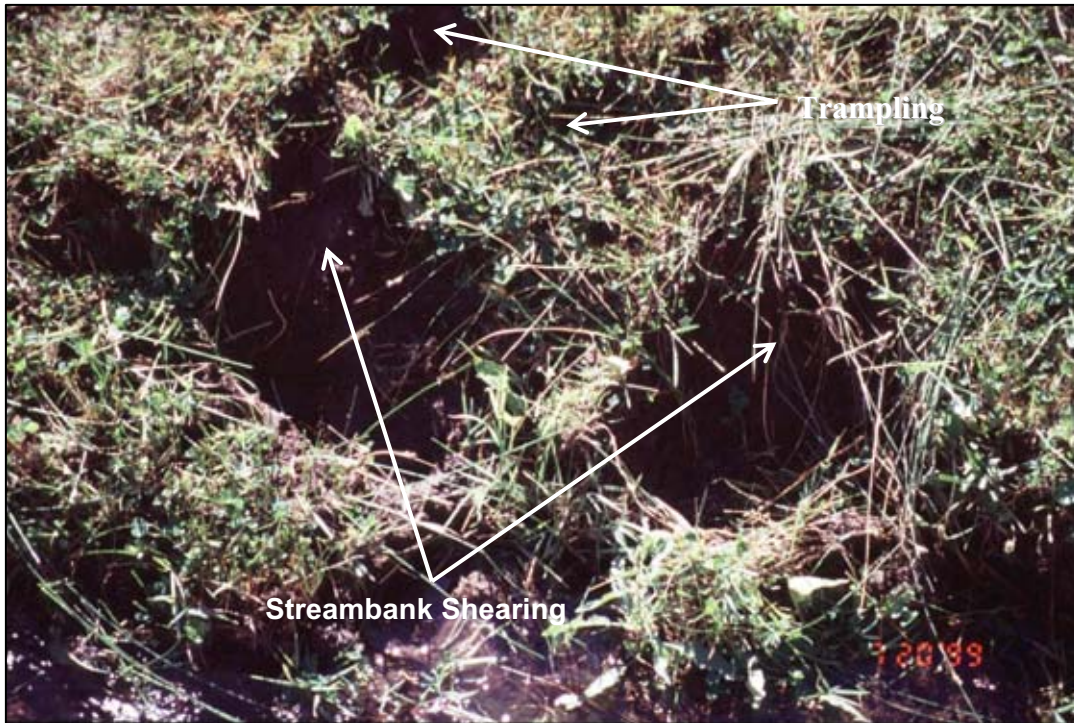
Figure 1—disturbance is considered trampling when a track caused by a large herbivore exposes at least ½-inch of bare soil. Streambank shearing is the physical displacement of part of the streambank downward toward the stream channel.

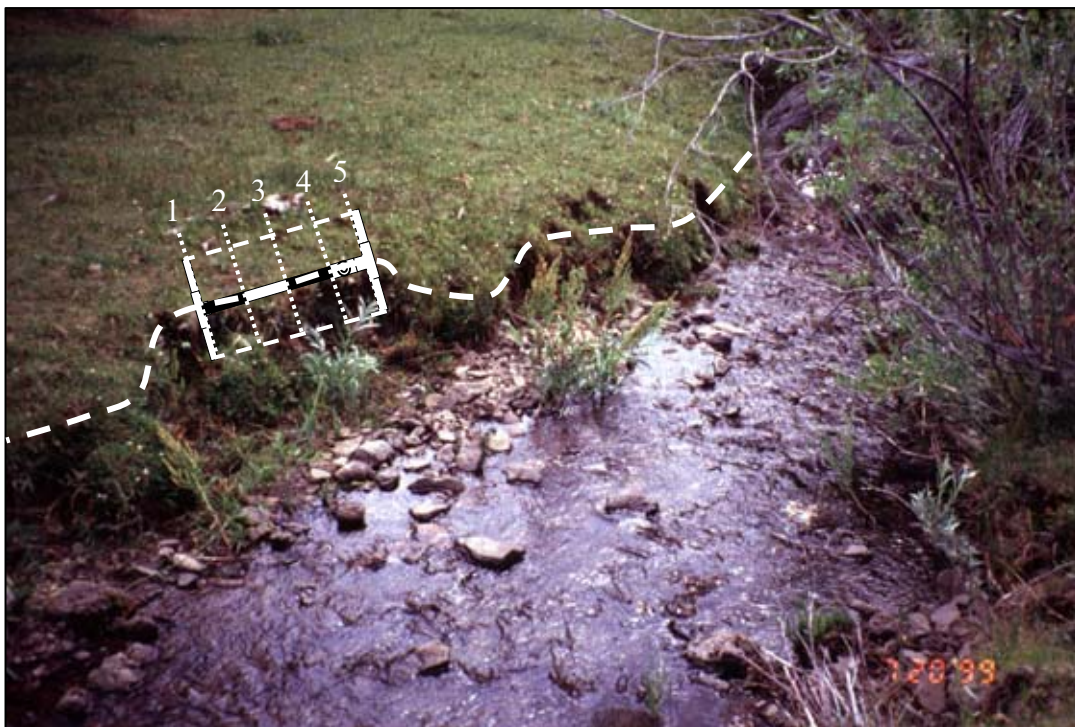
Figure 2—the monitoring frame is centered on the greenline and the number of lines ((0 to 5) that intersect streambank alteration (trampling or shearing) is counted and recorded. Lines 1, 2, 4, and 5 intersect streambank alteration. Four is recorded.

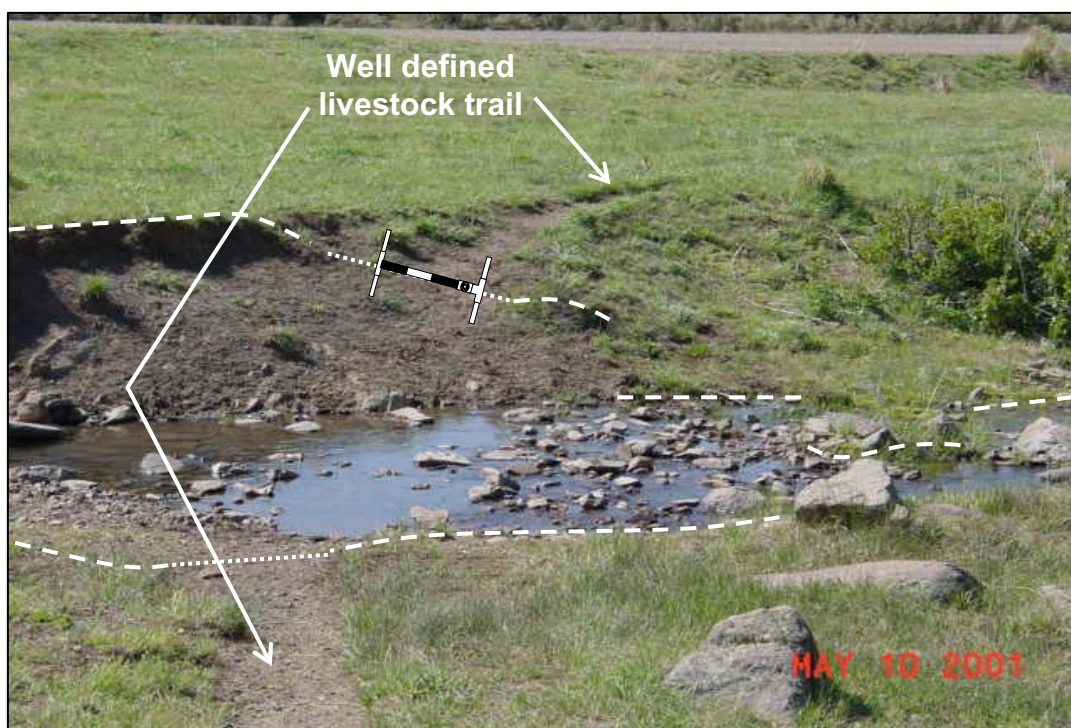
Figure 3—while livestock trails are not considered part of the greenline; they are considered for streambank alteration. The frame is placed at the point of the toe on a line that joins the greenline on either side of the trail. The example above shows the frame on a livestock trail that has been used during the current grazing season. Since all five lines intersect streambank alteration record five.

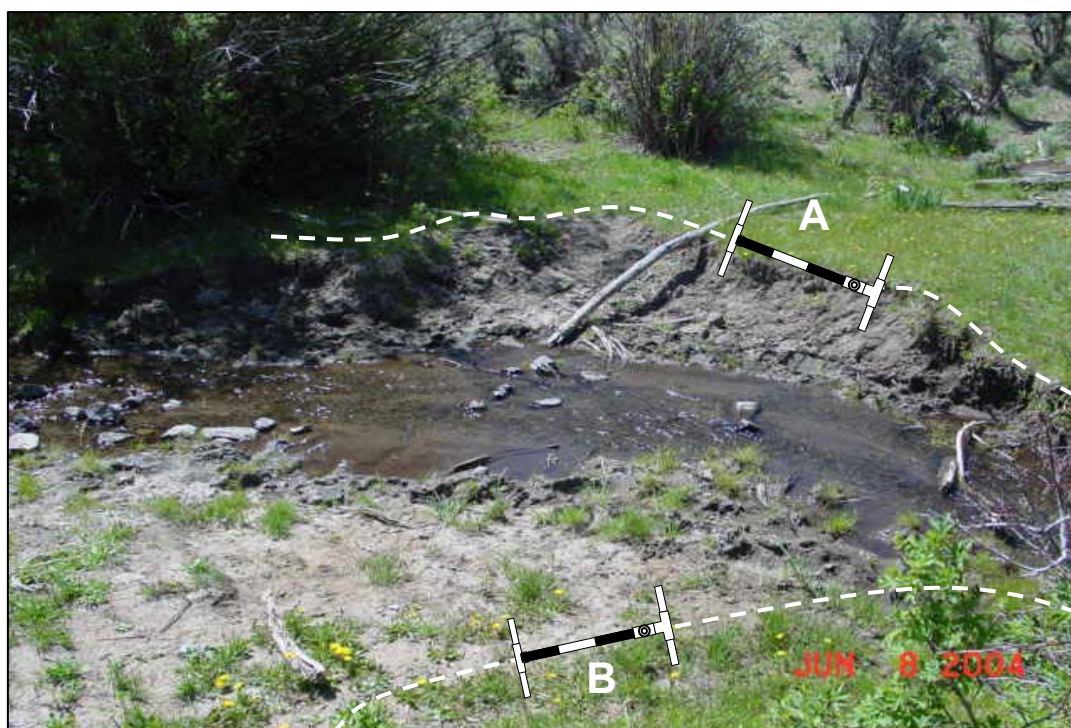
Figure 4—example A is heavily trampled and all five lines intersect streambank alteration. B shows no evidence of current years trampling that displaces soil at least 1/2 inch deep. A zero is recorded.

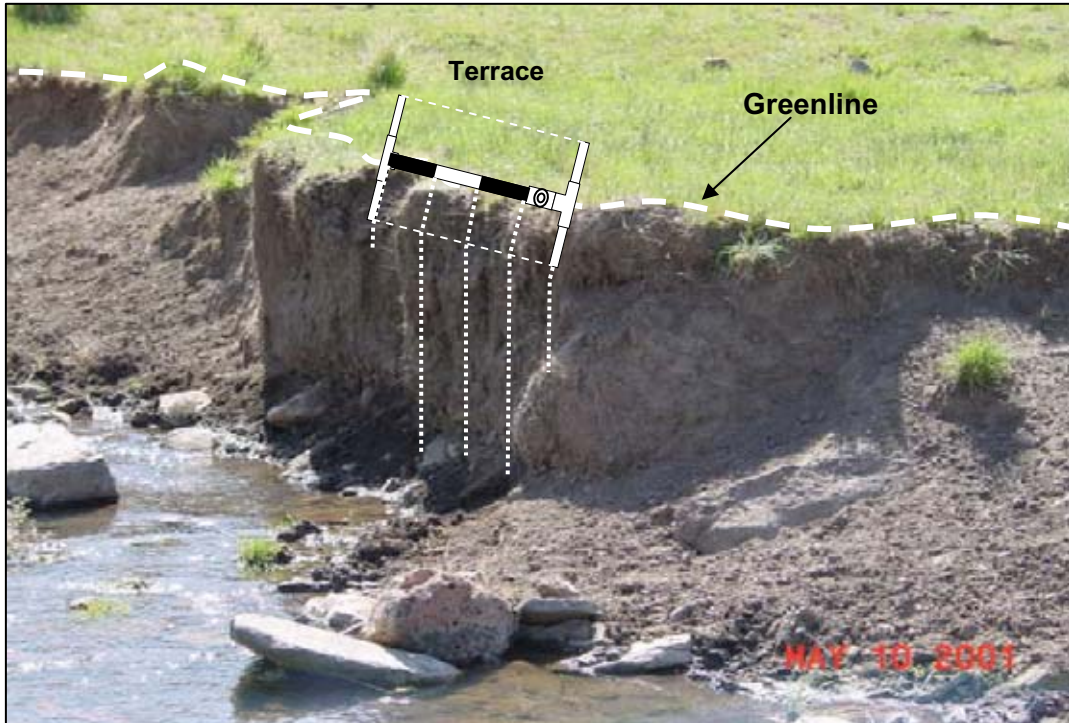
Figure 5—trampling on the terrace is not recorded as streambank alteration, only alteration occurring on the steep face of the bank. The lines are projected for the greenline down the bank, within the quadrat, to the water line. In the example above, line one, nearest the handle, does not intersect alteration. Line two does, lines 3 and 4, do not, and line 5 intersects a shear along the face. A total of two is recorded.

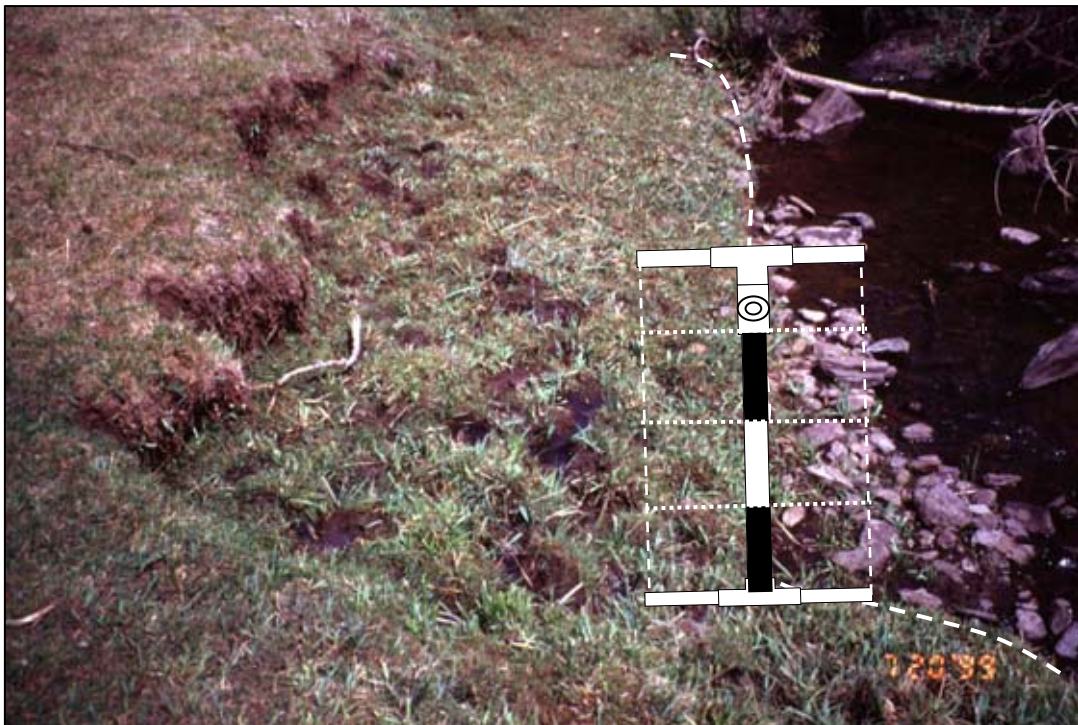
Figure 6—no evident streambank alteration intersects lines any of the lines within the quadrant. Zero is recorded.

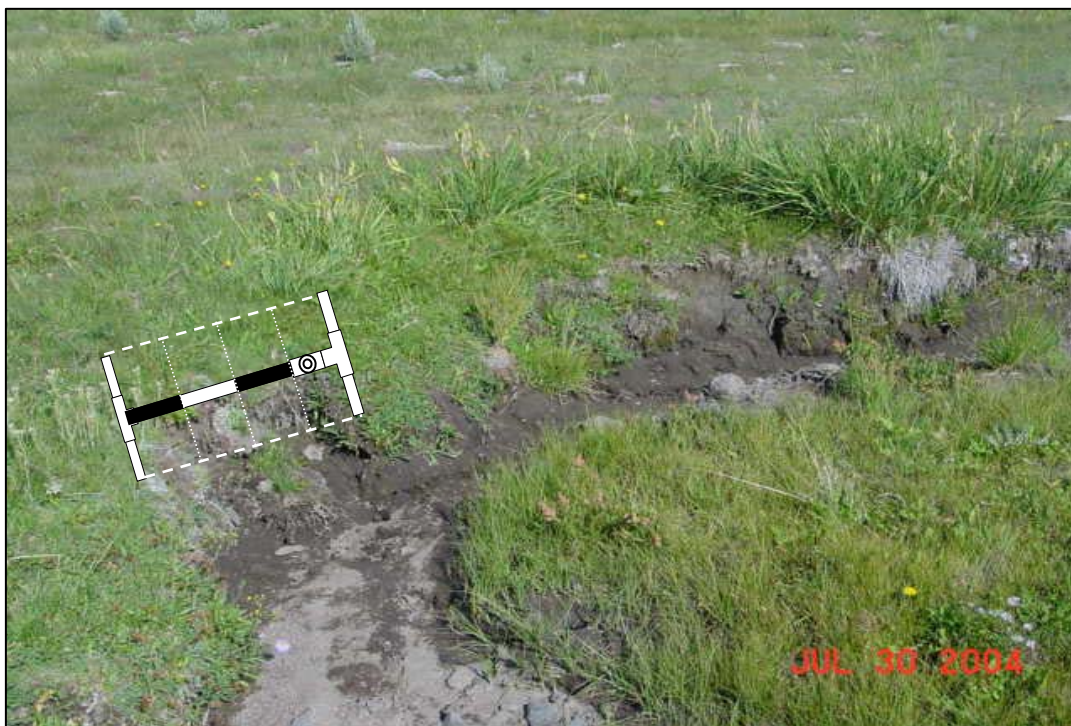
Figure 7—lines 2 and 4 intersect streambank alteration caused by livestock. Two is recorded.

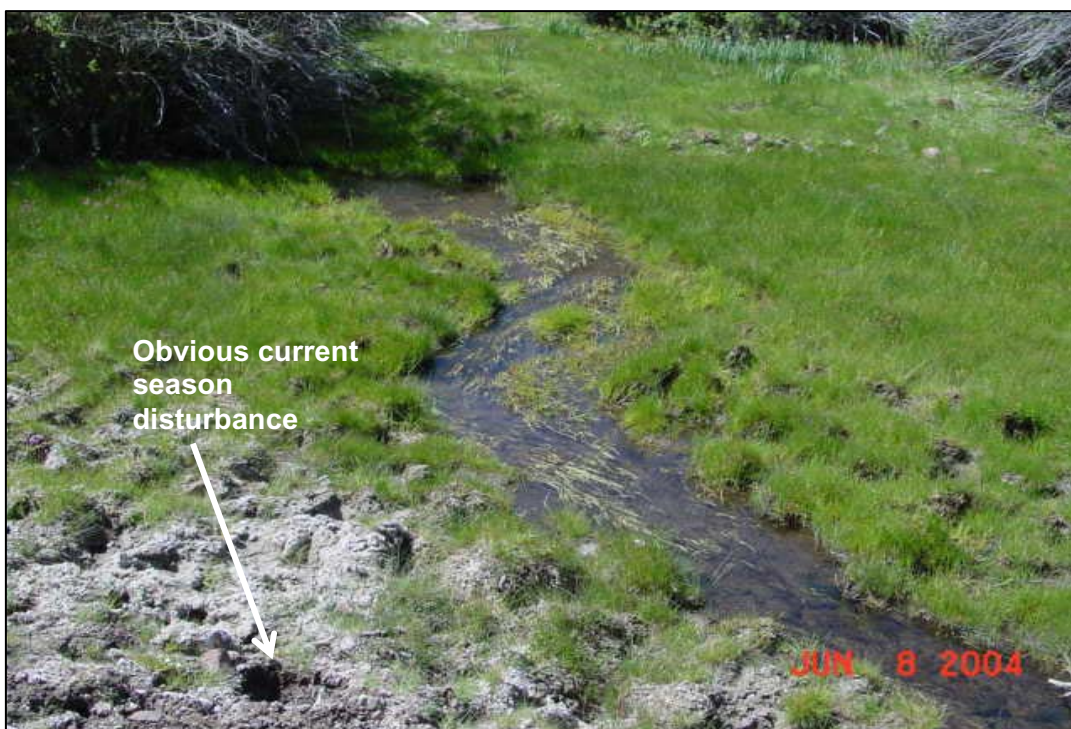
Figure 8—current season streambank alteration is difficult to distinguish from previous season use. Streambank alteration measurements should be made while livestock are still in the pasture or within two weeks of leaving. Streambank alteration should not be conducted on a site such as this when the alteration is difficult to distinguish from previous season grazing.
